LOSS CONTROL TECHNICAL BULLETIN

Reducing the Fire Hazards of Aluminum Wiring

The Problem with Aluminum Wiring: aka "Old Technology Wiring"

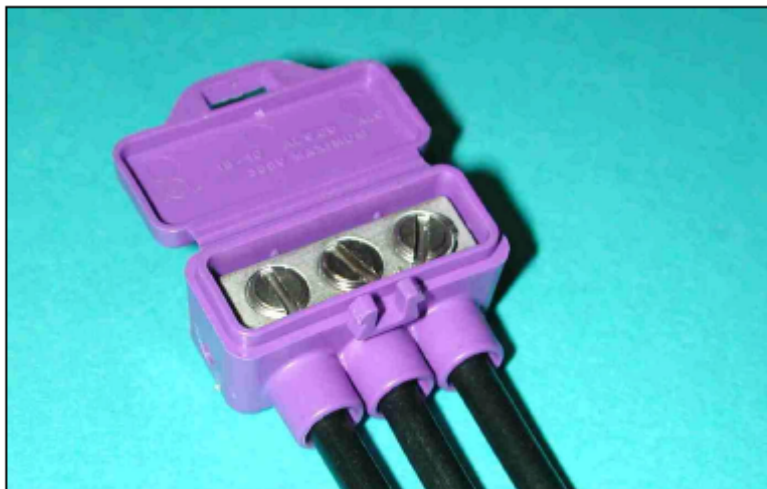
FIGURE 4 - King Innovation "AlumiConn" Connector

- 3. Use of ALUMICONN Connectors** – Refer to figure 4. This product was introduced in mid 2006 by King Innovation. If not adequately tightened, there is the possibility that connections could degrade. The manufacturer may be introducing a new holding tool for the field that will assist the installer in proper tightening.

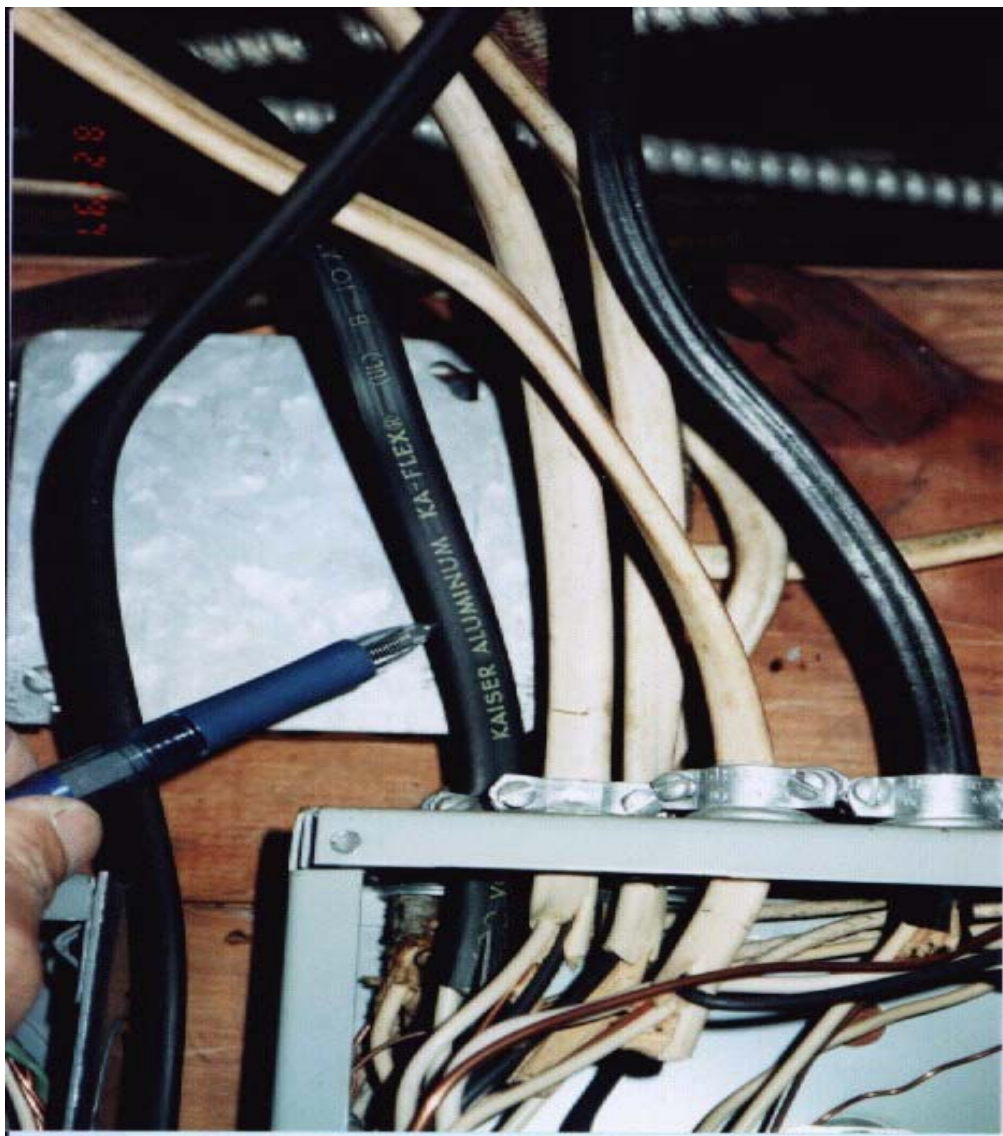
FIGURE #2

6. **Look for the word "Aluminum."** (See Figure 2). Look for printed or embossed letters on the plastic wire jacket where wiring is visible or at the electric panel. Some aluminum wire has the word "Aluminum" or a specific brand name such as "Kaiser Aluminum" plainly marked on the plastic wire jacket. This photo shows a dark colored wire jacket with green print indicating "Kaiser Aluminum." Some white colored plastic wire jackets are inked in red; others have embossed letters without ink and are hard to read. Try shining a light along the wire.
